**NON-JURISDICTIONAL
DETERMINATION OF WATERS
OF THE UNITED STATES
FOR
CASA GRANDE MOUNTAIN RANCH
IN
PINAL COUNTY, ARIZONA**

TECHNICAL MEMORANDUM

RE: Non-jurisdictional Determination of Waters of the United States for Casa Grande Mountain Ranch in Pinal County

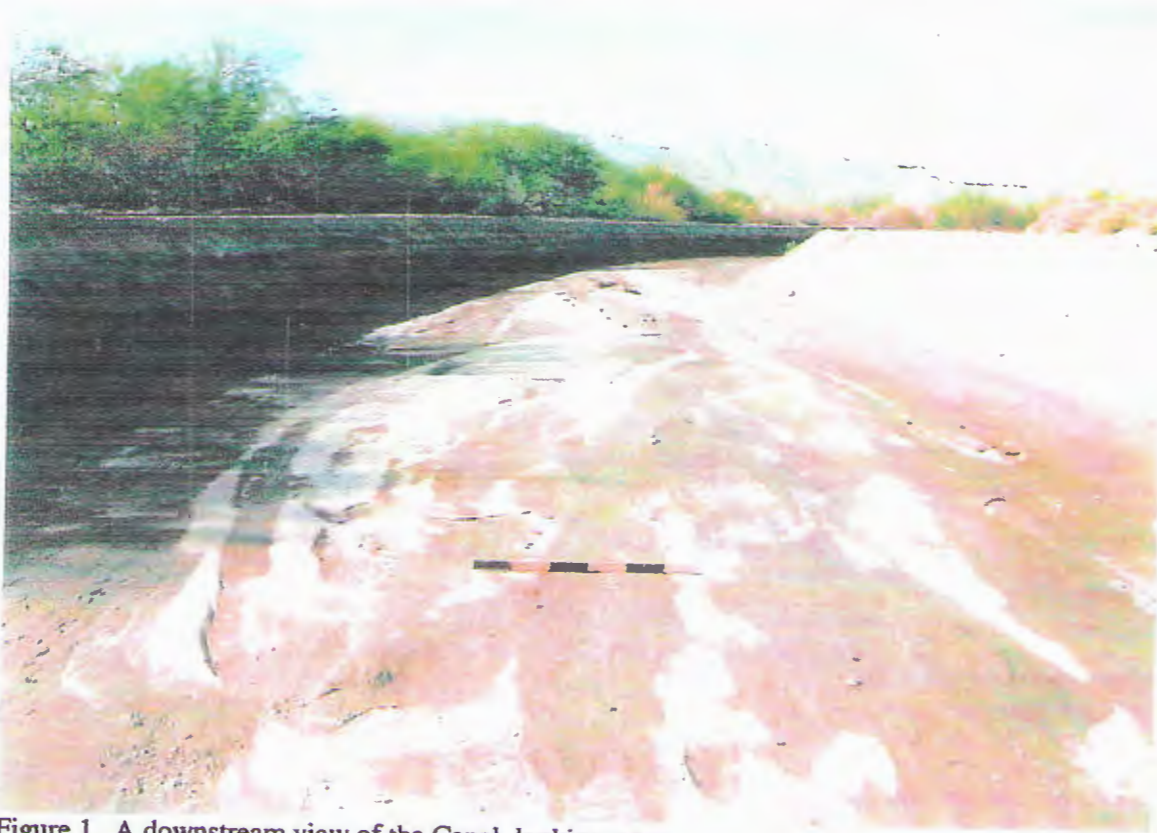
The Casa Grande Canal (Figure 1) is unlined, trenched, and roughly 30 feet wide. Its banks are elevated slightly from the surrounding areas, which prohibit surface runoff on the Parcel from entering the channel. The result is isolated areas of sheet flow that pond and percolate along the southern bank of the Canal (Figure 2). The Canal itself is property of the San Carlos Irrigation Project, an entity under Bureau of Indian Affairs jurisdiction, which receives irrigation water from Picacho Reservoir and San Carlos Lake. At the time of survey, the Canal was not delivering water.

Figure 1. A downstream view of the Canal, looking west.

SWCA does not consider the Canal to be jurisdictional WUS. While originating as surface water, the supply delivered by the Canal is probably not connected to a downstream surface water; rather, it is dispersed and consumptively used for irrigation throughout the San Carlos Irrigation Project area. Furthermore, the Canal itself is under the ownership of a federal entity, and may not be considered part of the project area for the purposes of assessing impacts on jurisdictional WUS.

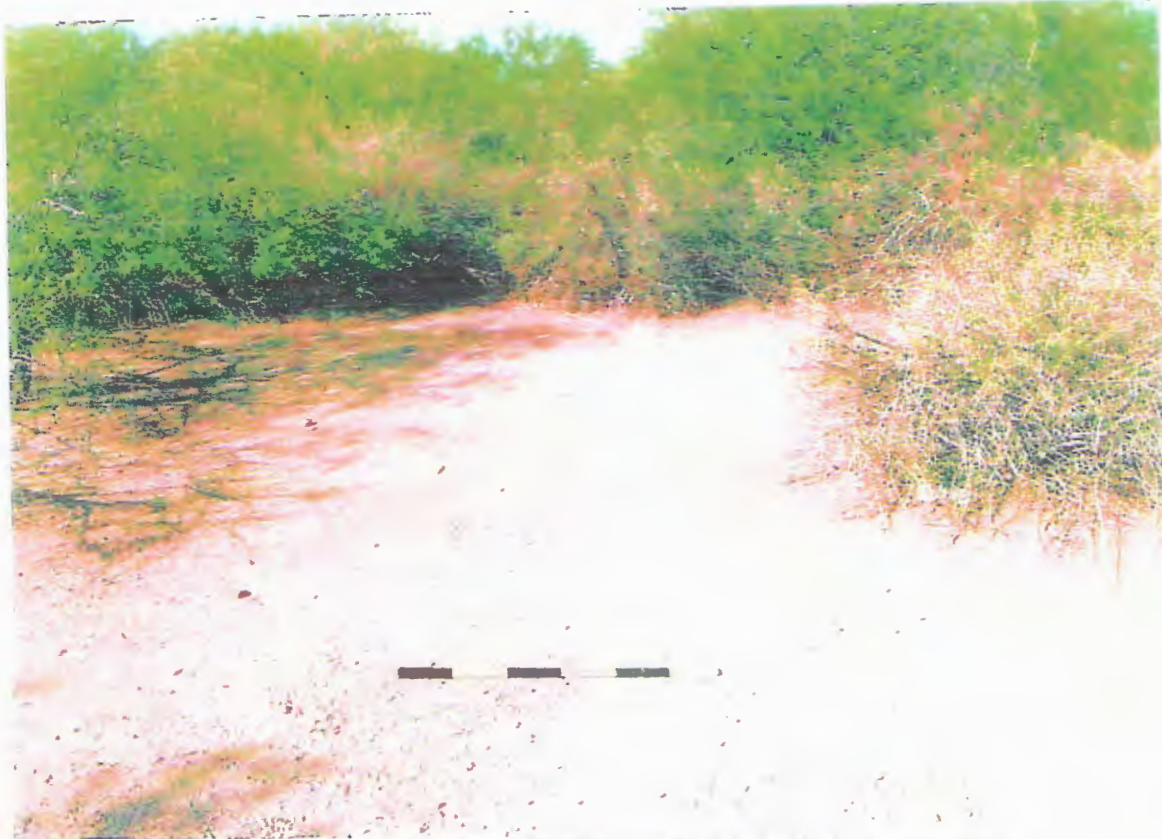
Figure 2. Extent of surface flow adjacent to the Canal, which is behind the vegetation.

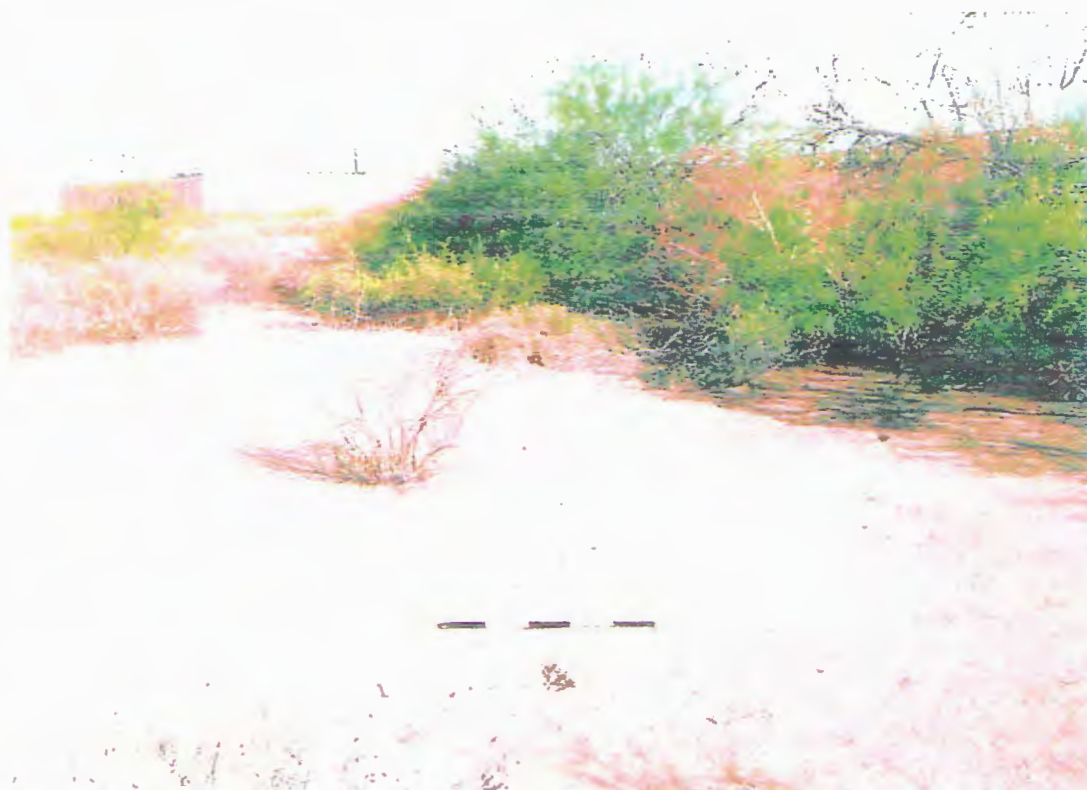
The northern portion of the Parcel consists of desert scrub vegetation and a recreational vehicle (RV) park. The majority of surface runoff terminates in the middle of the area, in a depression formerly used for stock watering (Figure 3). I-10 separates storm waters that collect east of the depression from downstream waters (Figure 4). In addition to the isolation from downstream waters, either by the depression or because of the presence of I-10, there is virtually no evidence of ACOE OHWM characteristics on this half of the Parcel. In all cases, there is no connectivity with surrounding areas or downstream waters.

Figure 3. Sheet flow dissipating into the ground and bounded by I-10, which is behind the vegetation to the right.

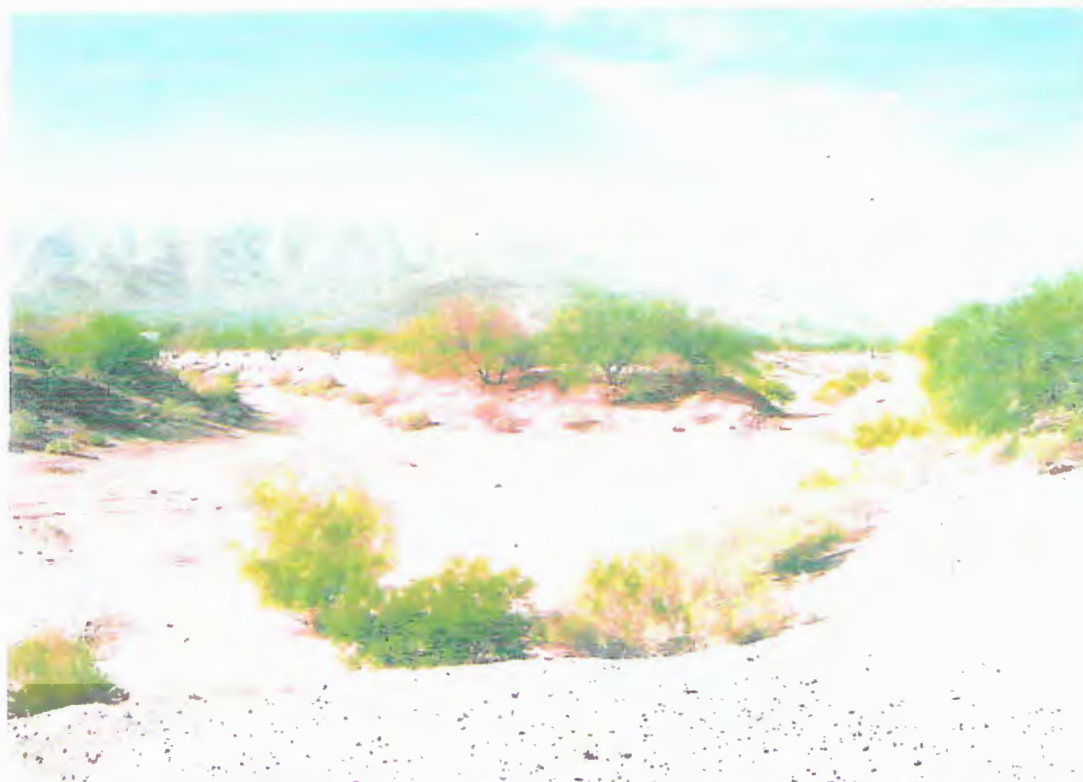
Figure 4. Depression and confluence of washes from the parcel, including some washes south of I-8.

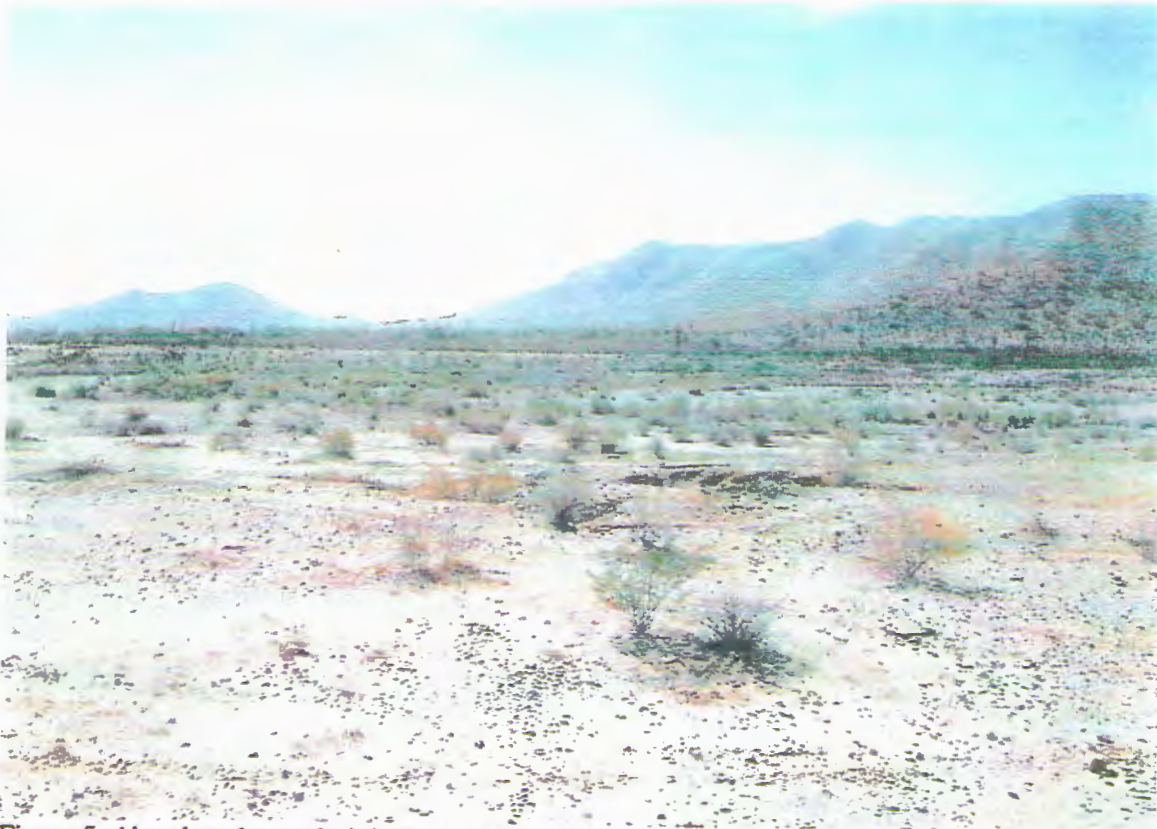
³ A gravel pit was depicted on the Casa Grande Mountain 7.5' USGS topographic map. The pit appears to have not been in use for some time (Figure 5).

There are many washes on the southern half of the Parcel that exhibit OHWM characteristics and that would normally be considered for potential jurisdiction. However, all washes here either dissipate into sheet flow within the Parcel or are channeled to one of the two sinks; most washes terminate in a gravel pit on the southern half of the Parcel (Figure 5); wash channels that avoid this depression pass under I-8 through a culvert by the northwest corner of the Parcel (Figure 6). These washes: 1) end up in the northern depression (see Figure 3); 2) dissipate as sheet flow on the property offsite, through culverts crossing under I-8, to the northwest of the Parcel (Figure 7); 3) or are isolated by I-10. Consequently, there is no perceptible surface connectivity between ephemeral washes beyond the parcel and adjacent properties.

Figure 5: Abandoned gravel pit in the southern portion of the parcel that captures most runoff.

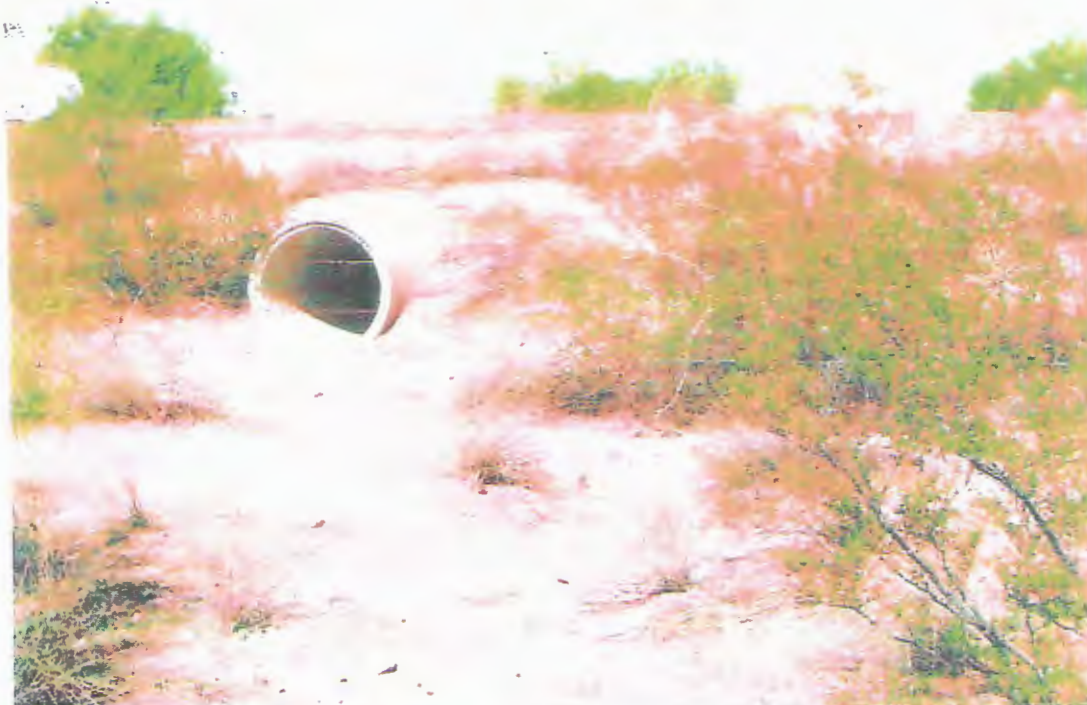
Figure 6: A culvert seen from the extreme northwest portion of the Parcel. Flows from the northern slopes of the Parcel are channeled here and other culverts under I-8 off property, which dissipate to sheet flow.

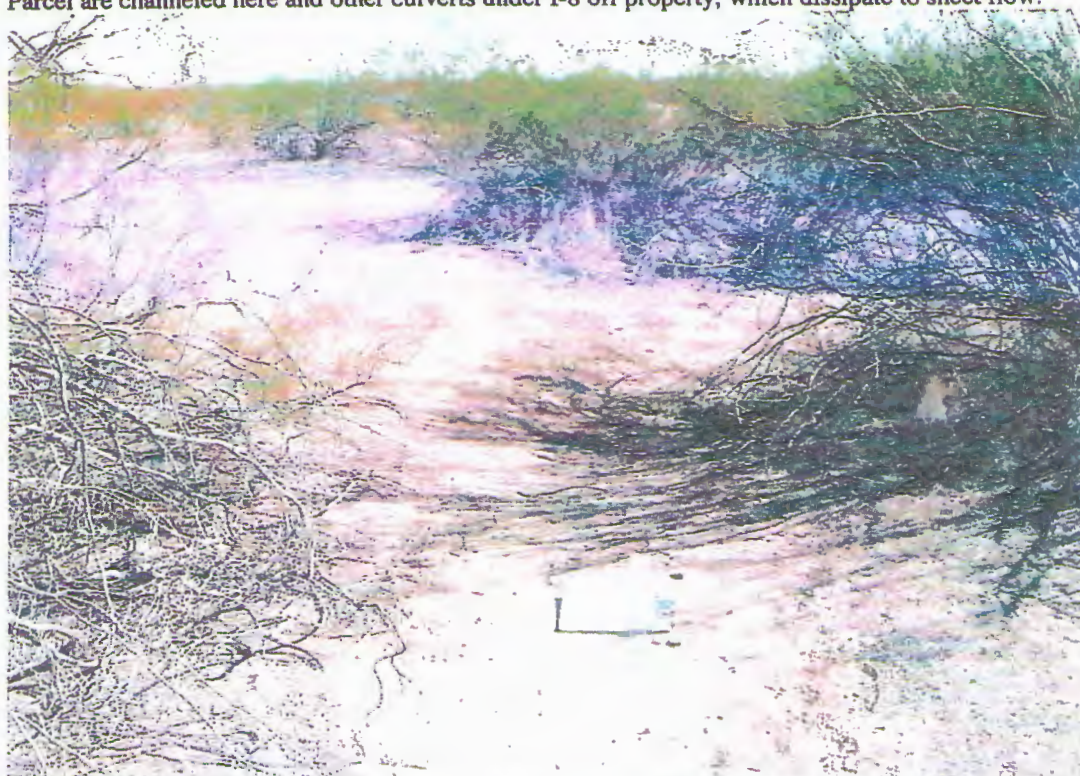
Figure 7: Resulting offsite dispersion and dissipation of flows from the culvert in Figure 6.
